The Historical Review as a Reference for the Islamic Heritage Restoration (Case Study: As-Sayyid Hashim Mosque)

Abstract

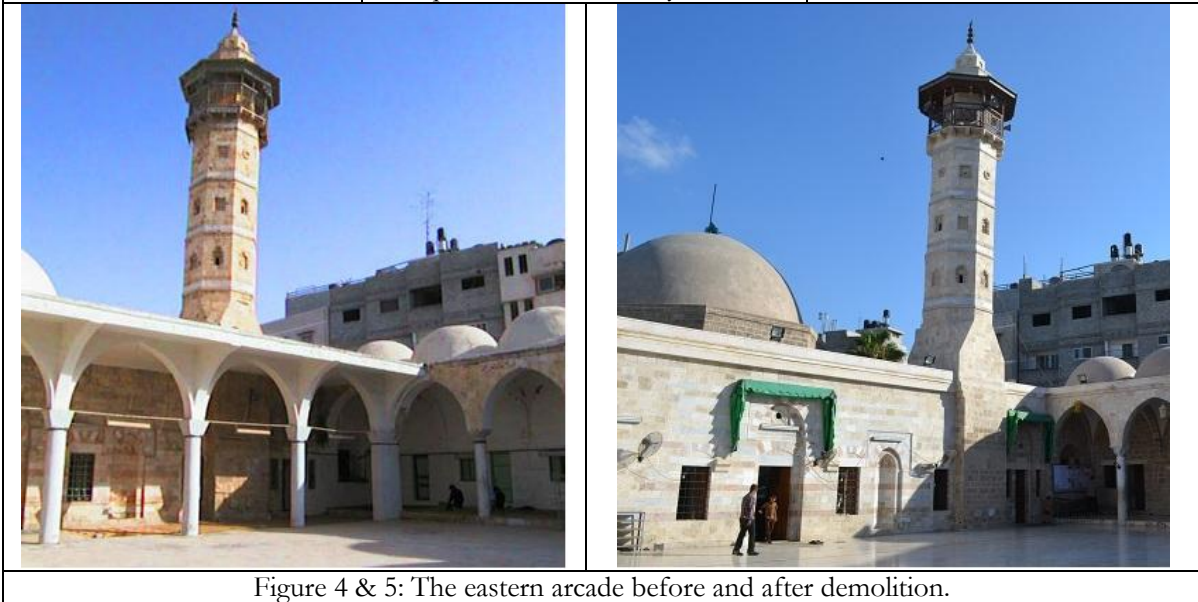
Figure 4 & 5: The eastern arcade before and after demolition.

There are four arcades in the mosque. All of them are original from the Ottoman era except for the eastern arcade which was built recently in 1986 (Al-Mobayyed, 1995). The arcade consists of concrete pillars and topped by concrete crowns, while the roof of the arcade was made of reinforced concrete which is considered an infringement to the archaeological character of the mosque. Limestone, sandstone, white and red marble were used in the interior facade of the arcade. The following table explains in more detailed the problem and how it was solved:

Problems and damages	Description of damage	Methods of Treatment
The reinforced concrete used to build the arcade is incompatible with the shape and nature of the mosque.	A reinforced concrete arcade was built in a way that contradicted the nature and characteristics of the original building material (i.e. sandstone and limestone).	Removed the concrete structure and applying materials and methods that do not harm the original building.
	There were damages in the arcade materials, and corrosion and wear in the rebar.	Treated the surfaces of intersections of the arcade in the old building and restored it with the same original finishing materials.
	The arcade covers the main eastern facade of the mosque and contradicts with the design of mosques with inner courtyard.	Combined the space of the arcade within the courtyard of the mosque.

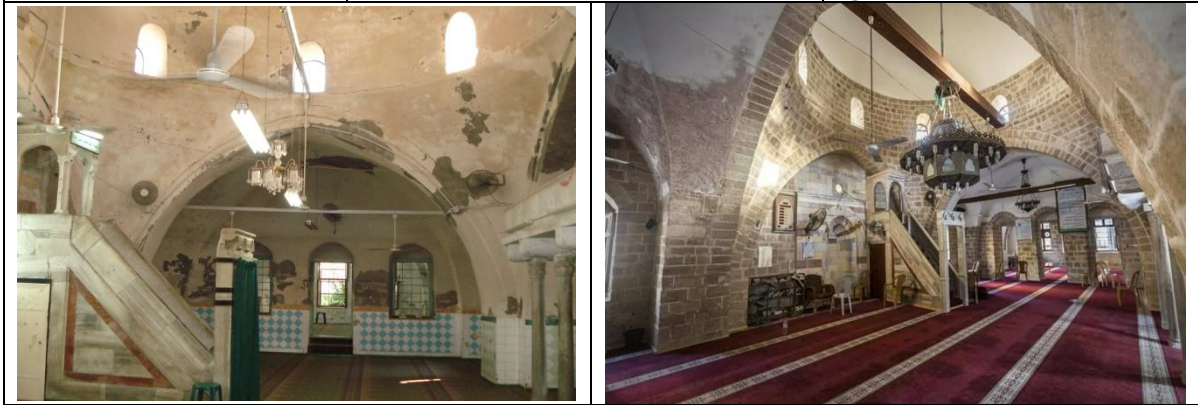
Figure 6 & 7: The treatment of the internal walls before and after restoration.

Usually, the mosque-goers would lean their backs on the wall while waiting for prayer times or reciting the Quran. This habit has led to the emergence of a problem in the walls from the bottom side (1.5 meters high). The caretakers of the mosque resorted to covering the walls with tiles bought from markets without any consideration of the historical or archaeological aspects. As a result, the general appearance has become psychologically displeasing for the mosque-goers in turn reduced the spiritual sense of the mosque as a place of worship.

Problems and damages	Description of damage	Methods of Treatment
Ceramic tiles on the internal walls of the prayer hall.	Ceramic tiles were installed on the surfaces of the interior walls, approximately 1 meter high, in various shapes and colours that are incompatible with the materials of the original walls. The ceramic also caused retention of moisture within the walls.	Manually removed all the ceramic tiles from the internal surfaces to preserve the walls.
		Cleaned the surfaces from dirt, mortar residue and minerals using small blunt equipment followed by using a brush.
		Washed the voids with distilled water.
		Applied a calcareous plastering which consisted of 4 sand, 1 lime, half white cement, 1 crushed pottery for 5 mm in the first layer and 1 mm in the second layer.
		Used thick wood to protect the bottom part of the walls for the mosque-goers to lean against the wall.

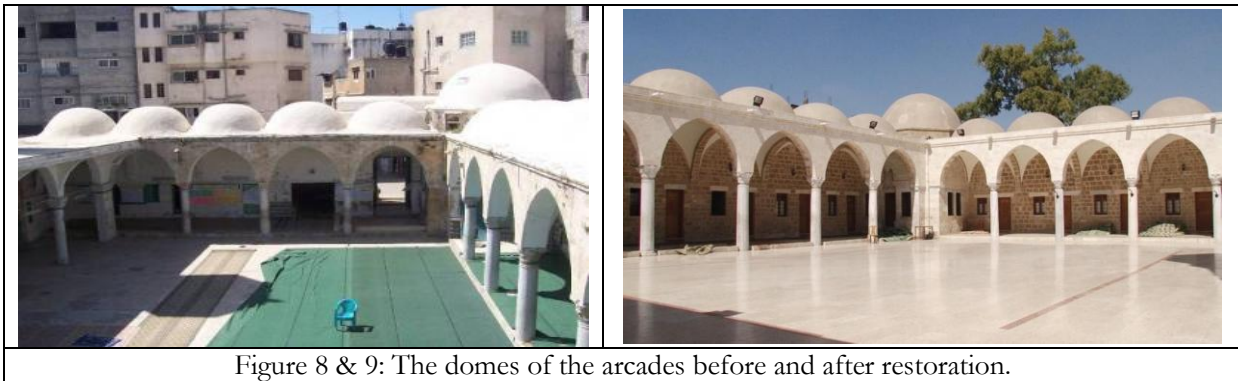
Figure 8 & 9: The domes of the arcades before and after restoration.

Inside the mosque, there are sixteen small domes and two large domes that covers the three arcades, in addition to the main dome. All these domes were restored in the 1970s, using reinforced concrete to fill the gaps and holes, adjust the distortions, fix the problems, and final coverage (Butt, 1995).

Problems and damages	Description of damage	Methods of Treatment
The main and arcade domes were covered with reinforced concrete.	The main arcade domes surrounding the courtyard were clad with 8-10 cm of reinforced concrete at random, which distorted the shape and rotation of the domes and also deformed the appearance and texture of the external structural materials.	Maintained the concrete layer while treating the damages as follows: 1- Levelled the surfaces of the domes by a special mould that ensures the regularity of the shape of the domes at all sides by adding calcareous mortar until reaching a regular surface level. 2. Softened the final layer of domes. 3. Isolated the cracks with suitable insulation materials and applied the isolation materials at several layers. 4. Painted the domes in creamy colour hues with a texture that matches the general character of the mosque.

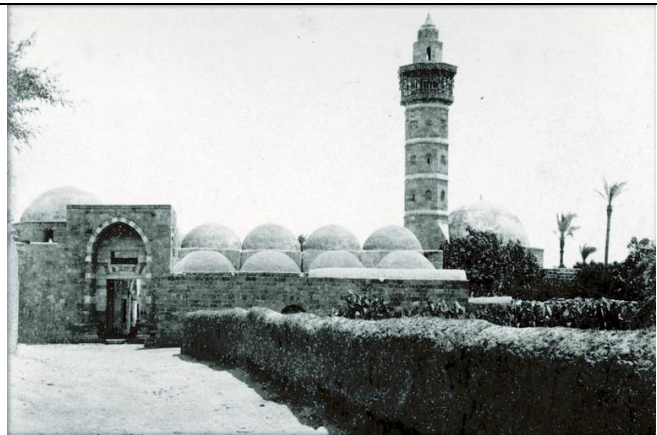
Figure 10: The mosque in 1898

In the original shape, the copper balls and crescent were not present above the minaret.

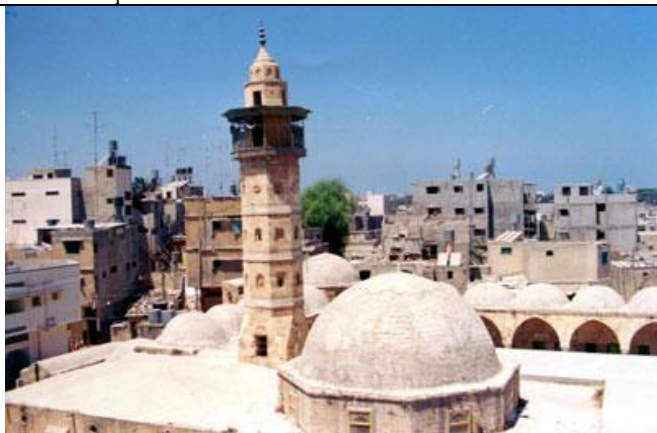
Figure 11: The mosque in 1980

The copper balls and crescent were added in 1920.

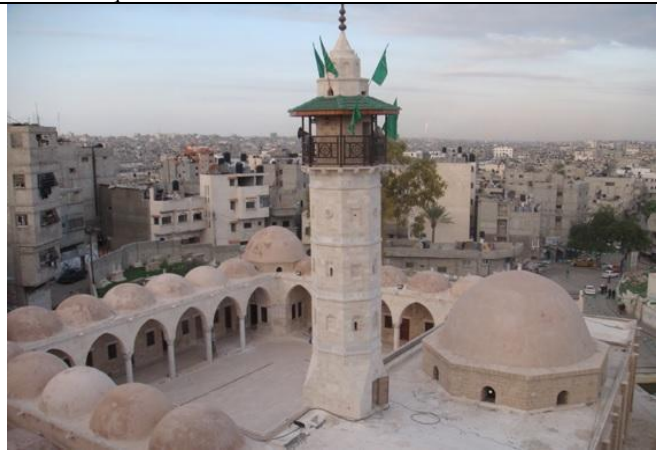
Figure 12: The mosque in 2010

After the comprehensive restoration, the copper balls and crescent still existed.

Problems and damages	Description of damage	Methods of Treatment
Inclination and lack of verticality of the minaret's body.	<ol style="list-style-type: none"> 1- The survey reviews showed that the inclination of the minaret changes with height, as the inclination of the first block, from the roof to a height of 4.5 m, was little (i.e. not exceeding 0.2%). 2- The inclination of the second block, 2.15 meters high from the end of the first block, was 0.8%. 3- The inclination of the third block (i.e. from the end of the second block to the end of the minaret) was 3.2%. 4- This inclination may be due to a defect in the original construction or a result of lateral forces from an earthquake. 	<p>The results of the structural study showed that the inclination of the minaret was not dangerous and remained safe. The minaret was able to withstand the forces caused by the inclination in addition to the lateral forces caused by earthquakes or winds. Therefore, there is no immediate need to rectify the inclination of the minaret.</p> <p>The interviews that the consultant conducted with the elderly in the area indicated that the inclination in the minaret had existed since it was first constructed. The information was consistent with the nature of the irregular tilt along the height of the minaret and varied in the three masses of the minaret.</p>

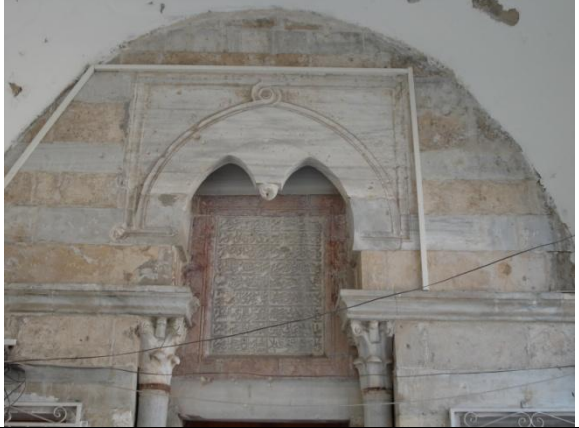
<p>Figure 13: The grave inside the tomb</p>	<p>Figure 14: The entrance of the tomb</p>

The tomb is located at the north-western corner of the mosque. It is a 25 m² room with the grave closer to the eastern side of the room. The tomb was recently covered with marble and has arches of gypsum on the corners. The tomb is topped by a high dome on an octagonal neck that has windows distributed radially around the neck. At the entrance of the tomb, there are marble columns on both sides topped by marble crowns and ending with a marble composite arch that includes a set of poetic texts engraved on a stone below it, as shown in the pictures. The prayers in the mosque were not limited to Sunni-Muslims. A decade and a half ago, the "Bohra" (a subgroup within the Ismaili Shia) had organized visits to the mosque and performed their private religious rituals as they considered As-Sayyid Hashim mosque one of the five sacred places in the world because of the tomb of Hashim bin Abd Manaf, the grandfather of Prophet Muhammad (Campo, 2009). The sect restored the tomb by themselves at their own expense. They spent about thirty thousand dollars for this purpose (Sharon, 2008).

Problems and damages	Description of damage	Methods of Treatment
<p>The moisture was trapped in the sandstones, causing erosion to occur.</p>	<p>1- The inner walls of the tomb were covered with thick marble slabs, which trapped moisture inside the walls and caused the stones to erode. 2- The problem started since the religious Bohra group carried out the restoration work which ended up damaging the tomb instead.</p>	<p>1- The marble slabs were carefully and precisely removed to be used and re-installed. 2- The lining of walls was removed. 3- The walls were dried in two ways: (1) making small holes in the walls and injecting them with special substances that absorb water and then get rid of it; (2) dried using standard oscillating fans.</p>
